Client:	Specialist Castings Ltd Tatham Street Sunderland Tyne & Wear SR1 2AG				
Title:	Evaluation of corrosion of the poor surface finish at the pouring basin of the Anotec high silicon cast iron tube anodes				
MSL Report No:	2726.17a	Date:	20.05.2017	Issue No:	1
Description:	Electronic Format				
Client Ref No:	281709				
Prepared by:	Lovlesh Beharry, MEng Engineering Manager				
Reviewed by:	Ron Scott BSc, C.Eng, MIMMM Technical Director				
Signed / Quality Stamp:

Summary

The report outlines the corrosion test that was carried out on the Anotec anode around the pouring bush. The test was carried out for 60 days in an electrolyte of 3% sodium chloride. The corrosion rate was 298 g/A.Year

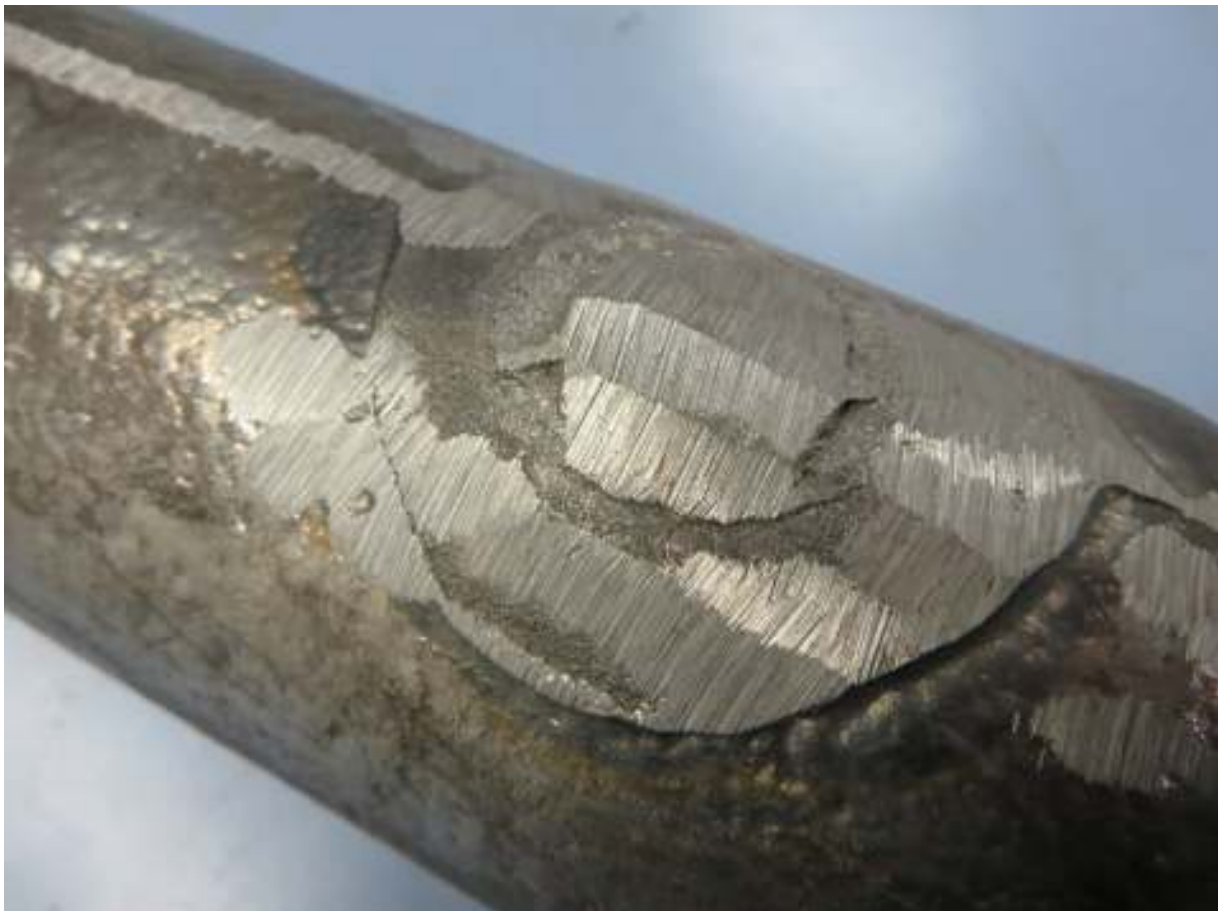
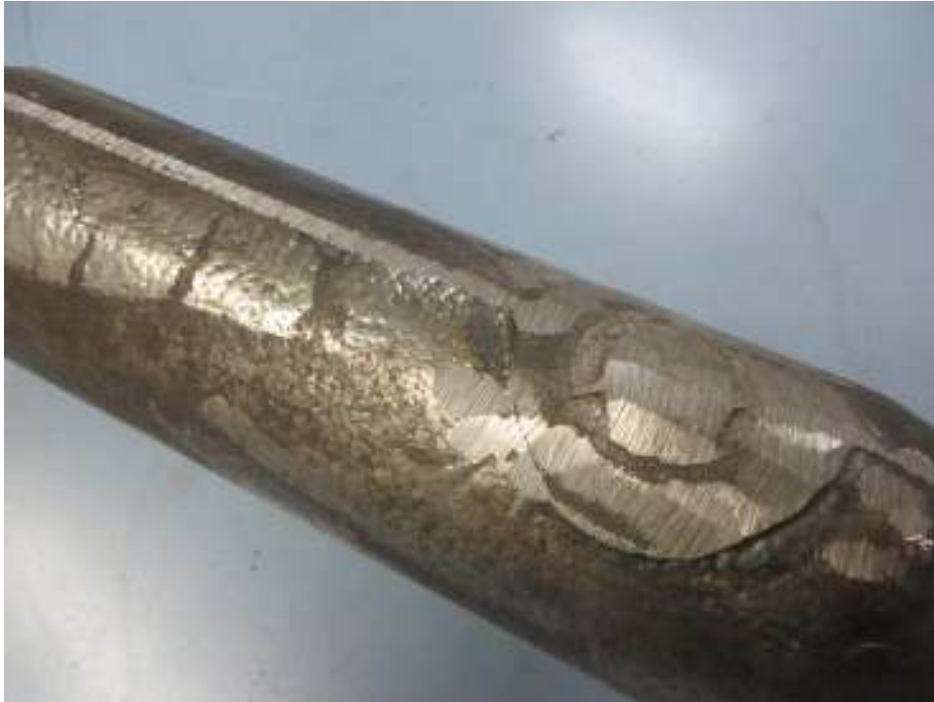
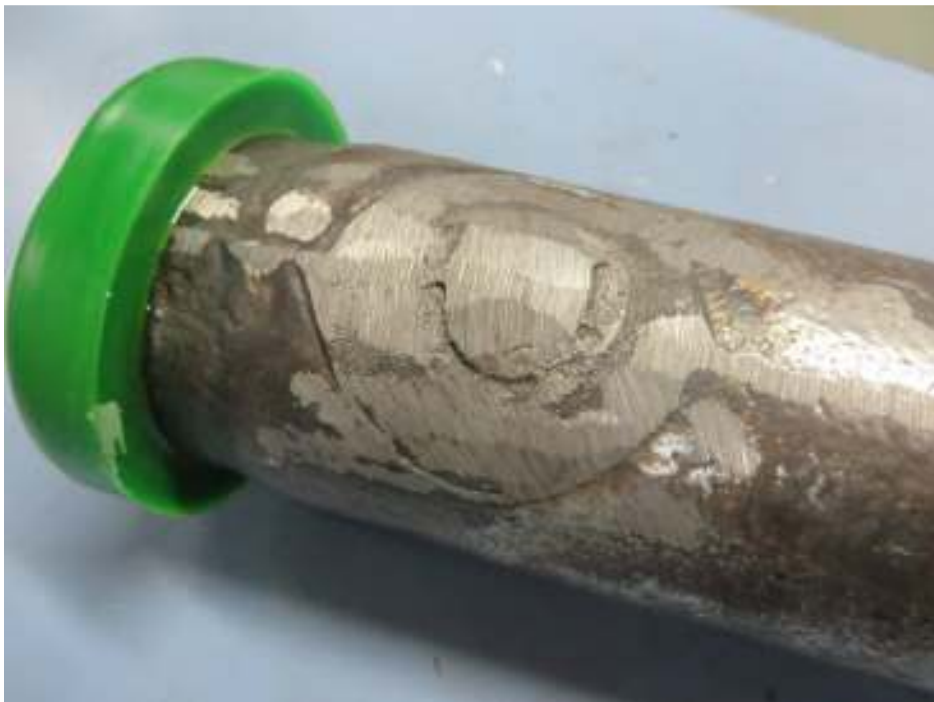
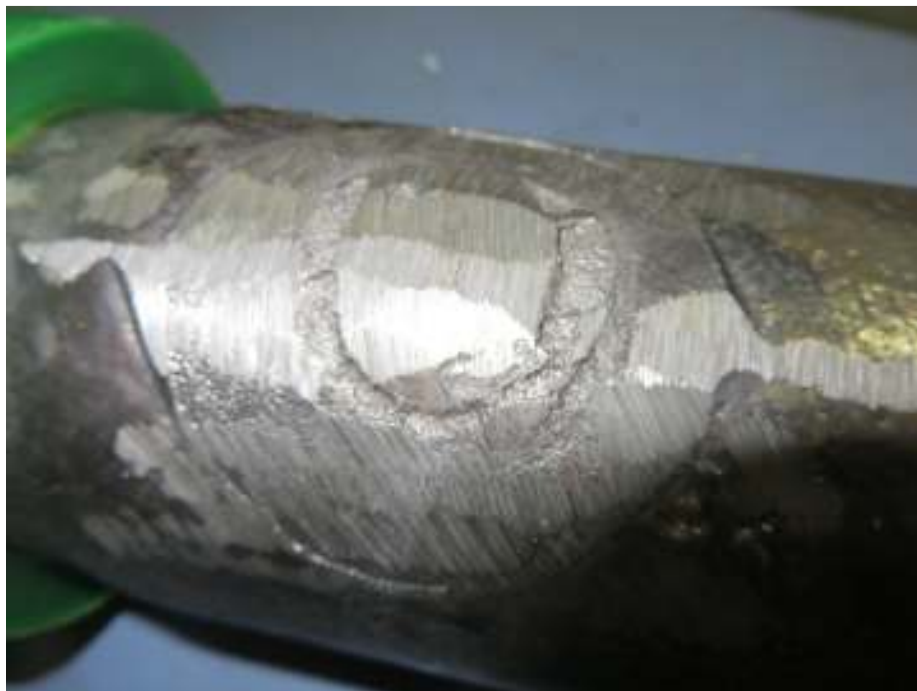
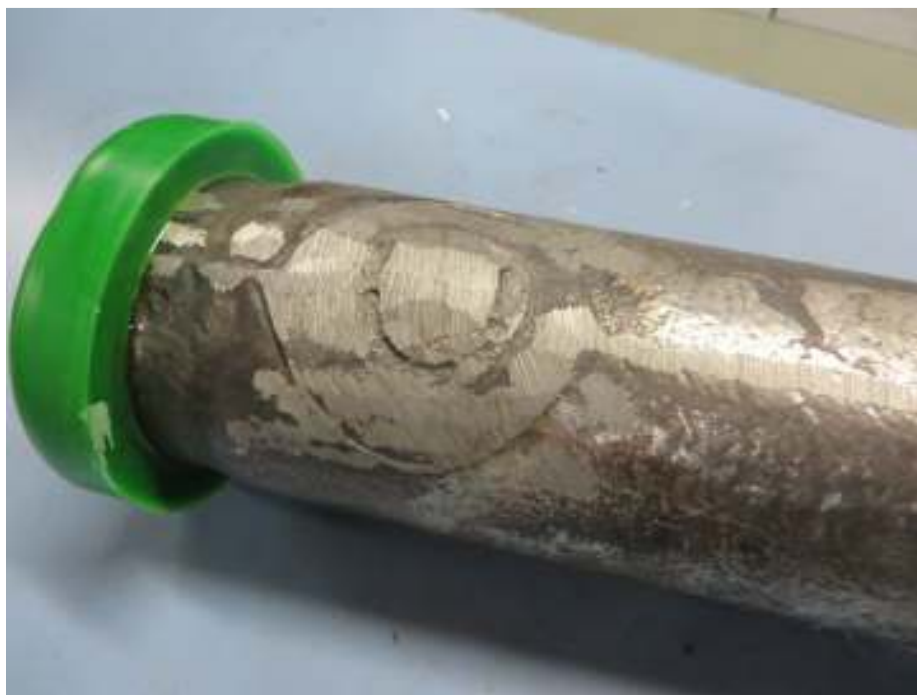
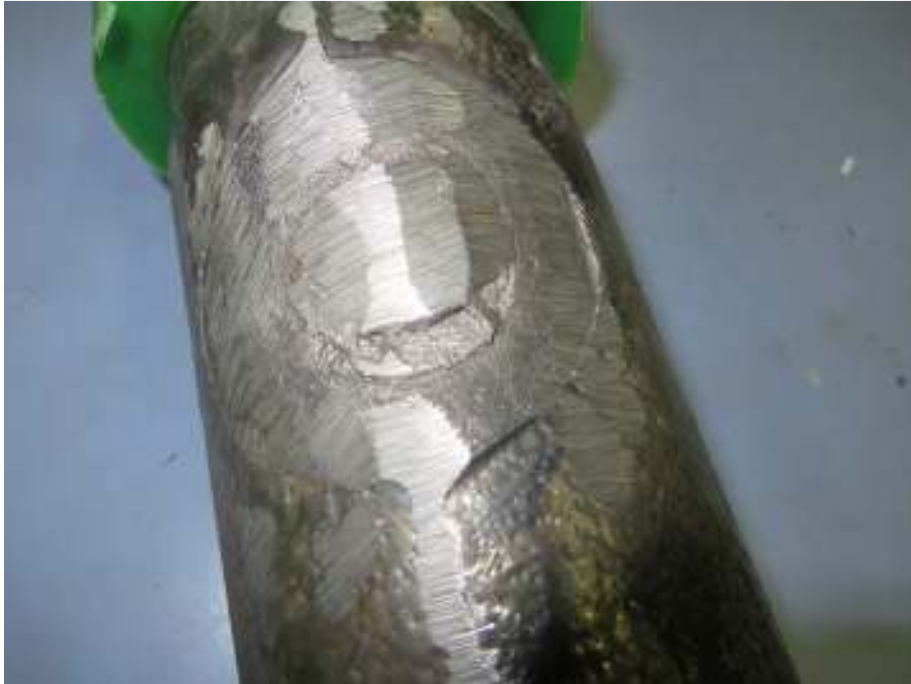
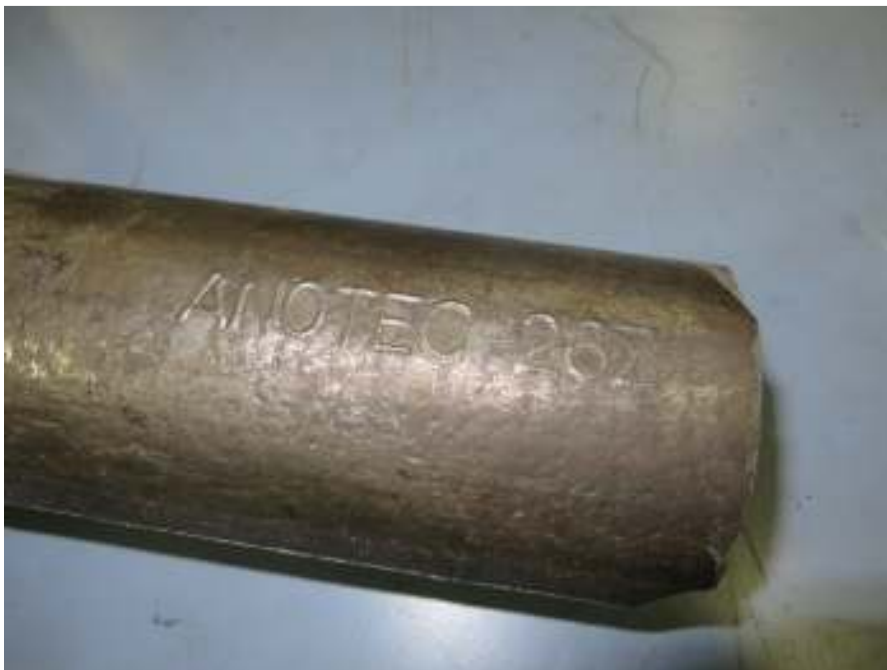
Photo 1 to 7 Prior to corrosion test

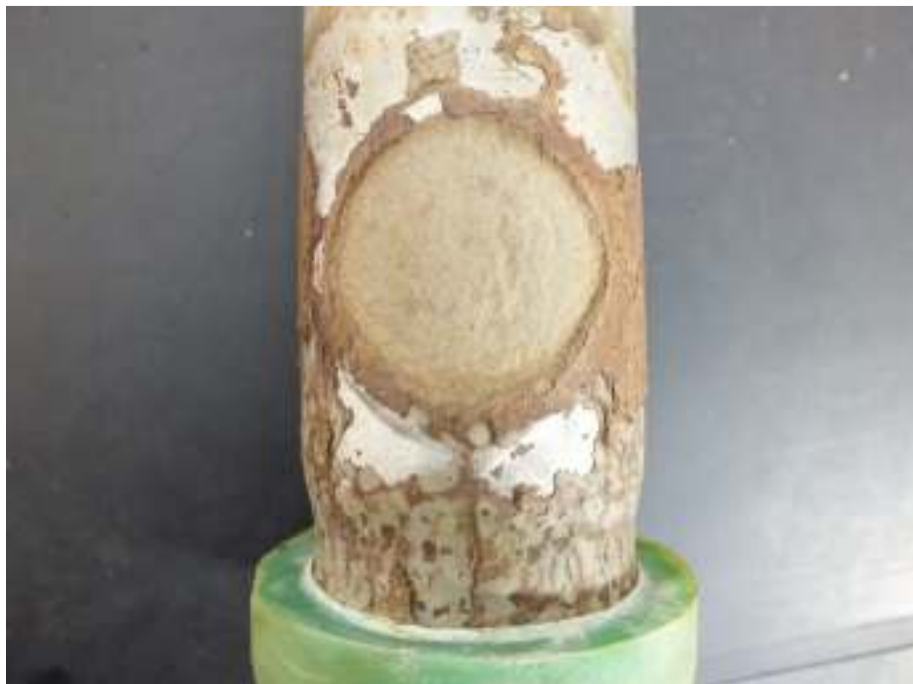
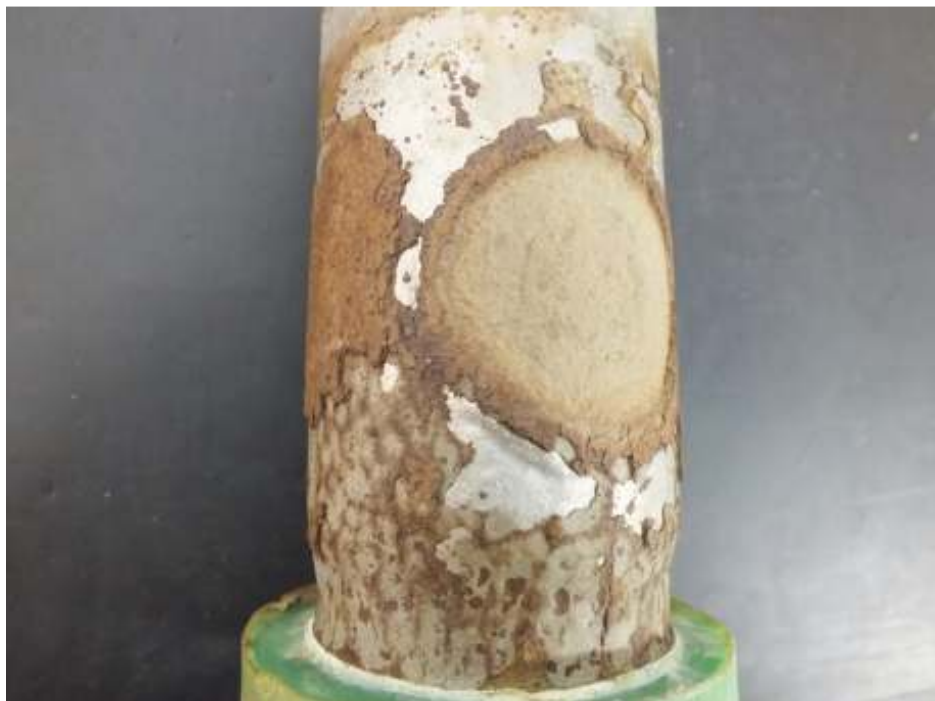
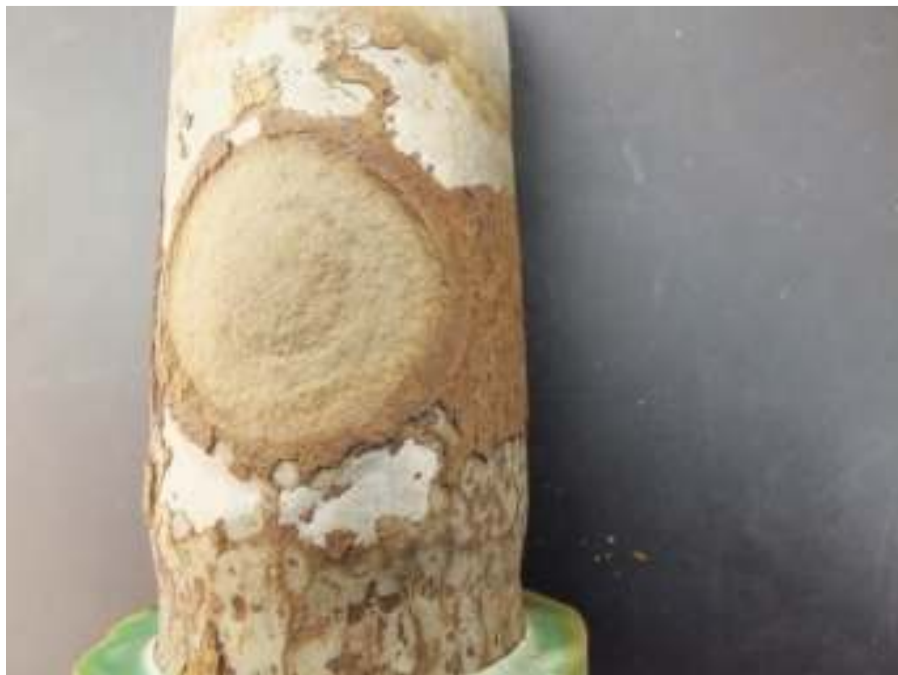
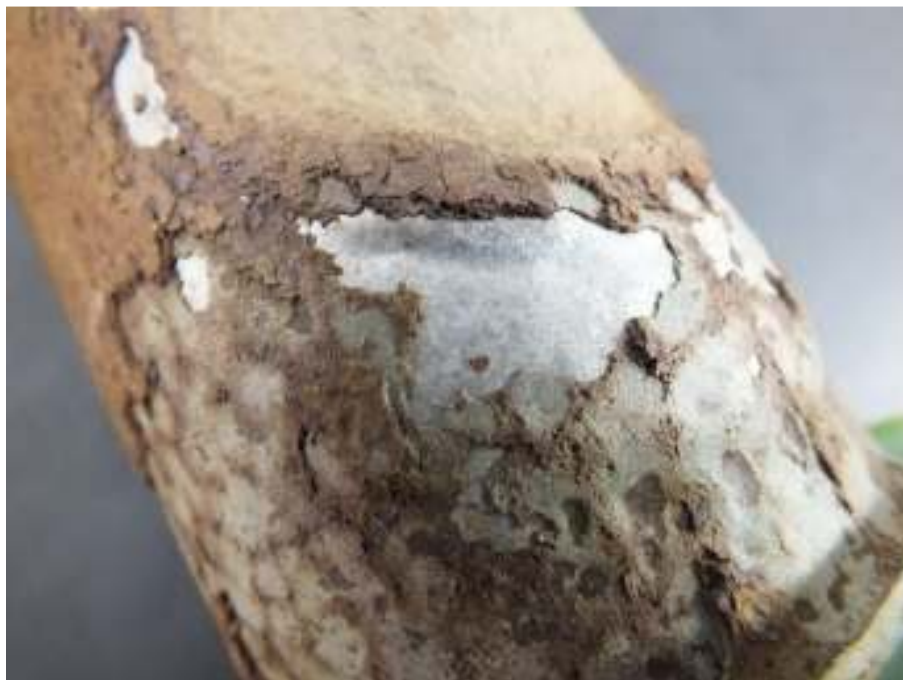
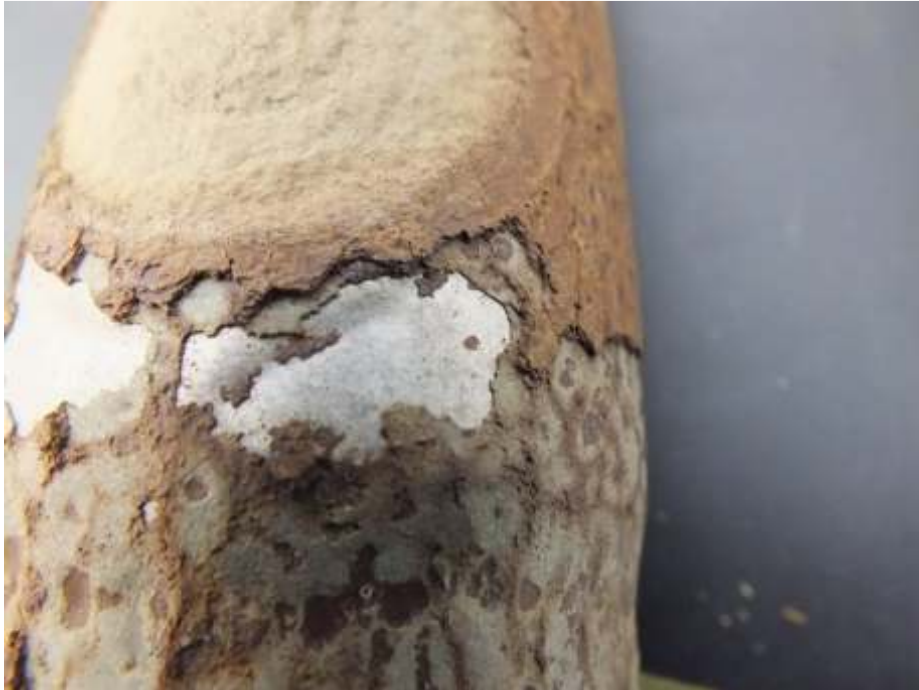
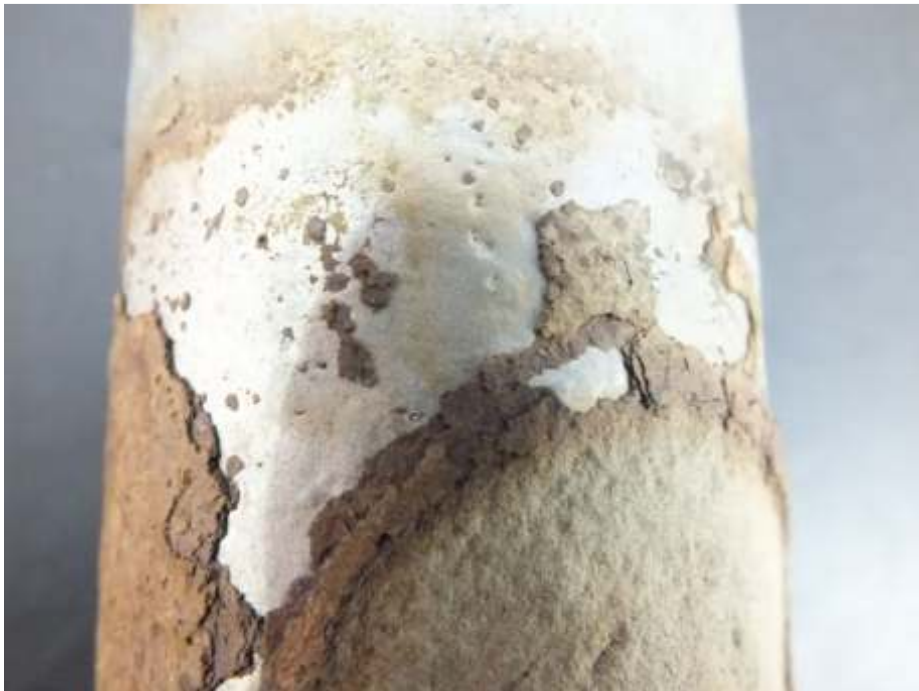
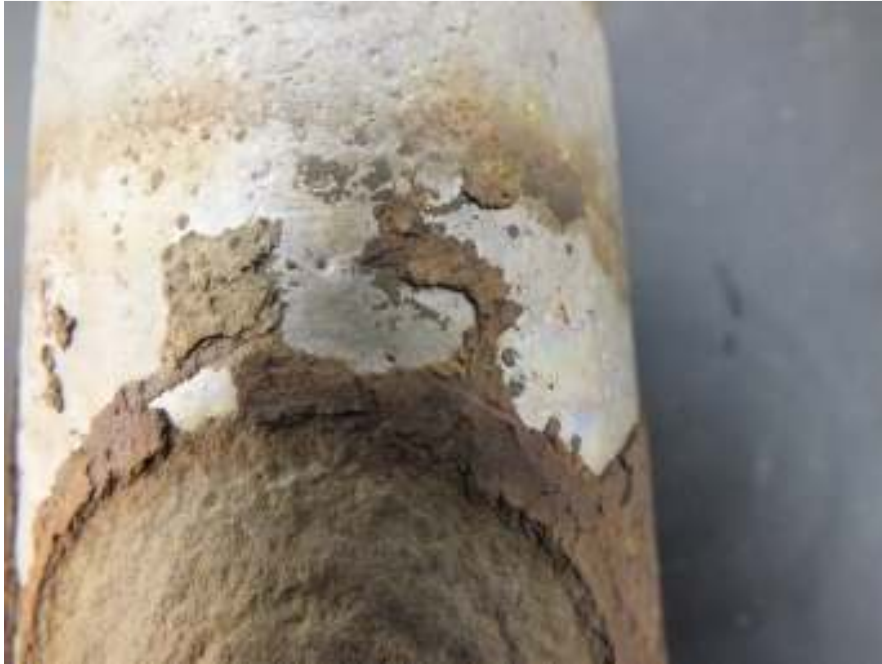
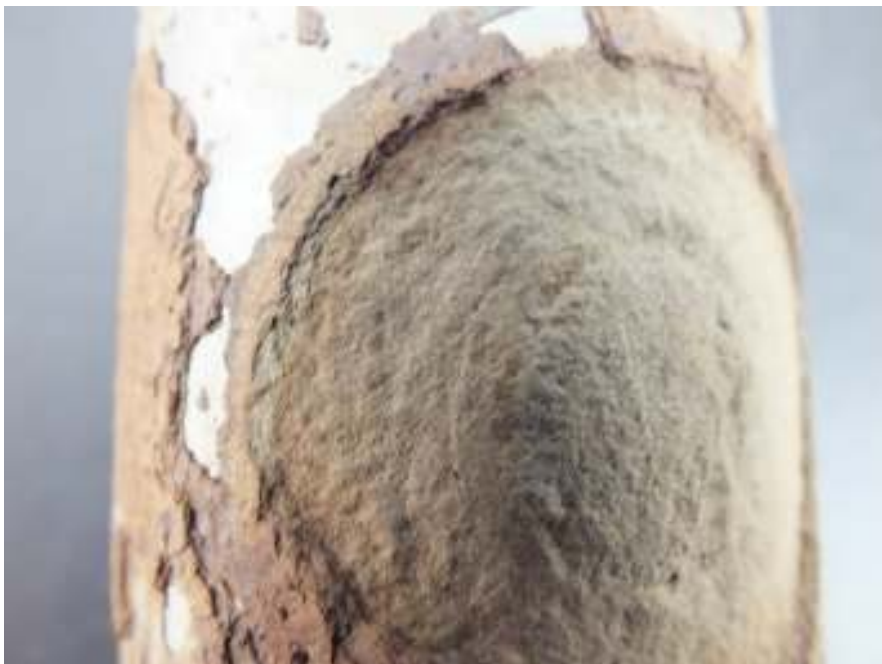
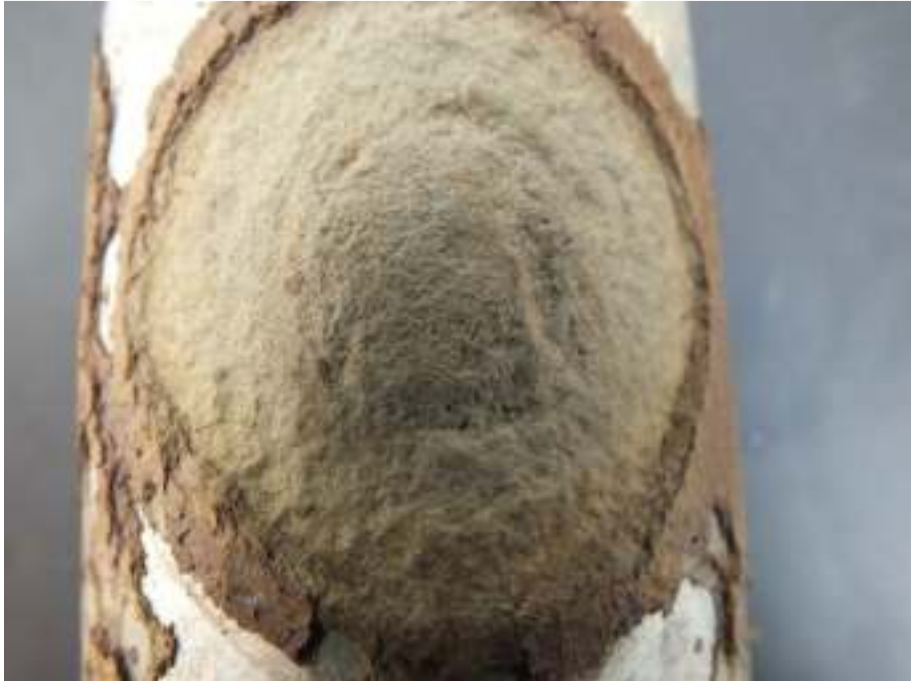
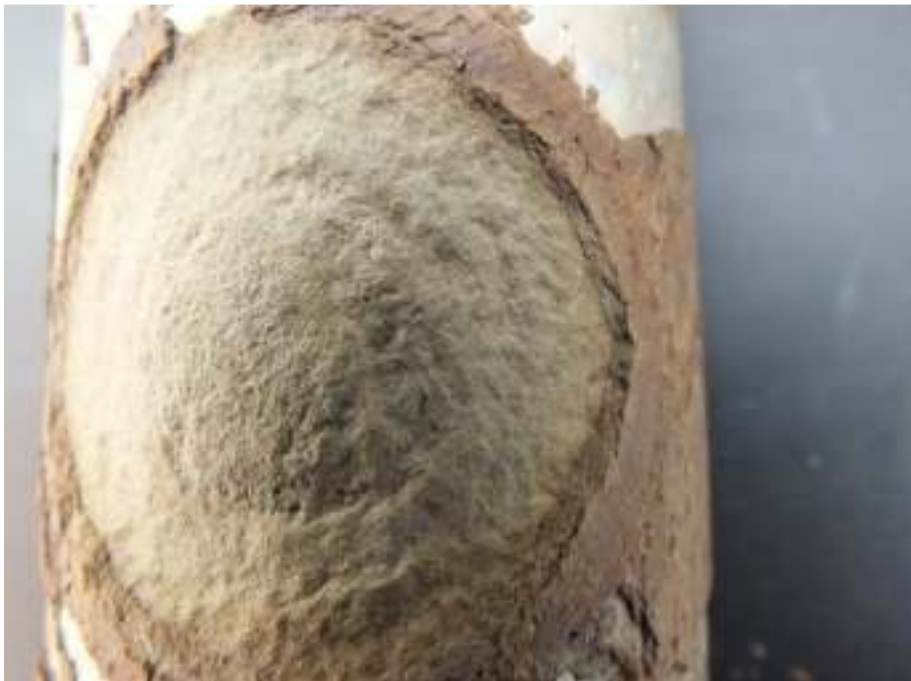
Photos 8 to 17 After removal

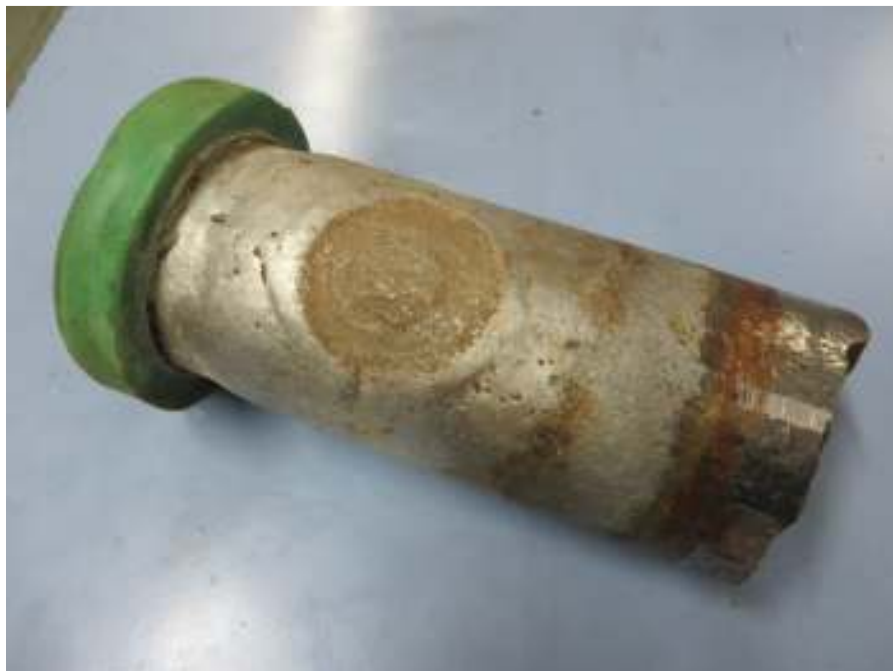
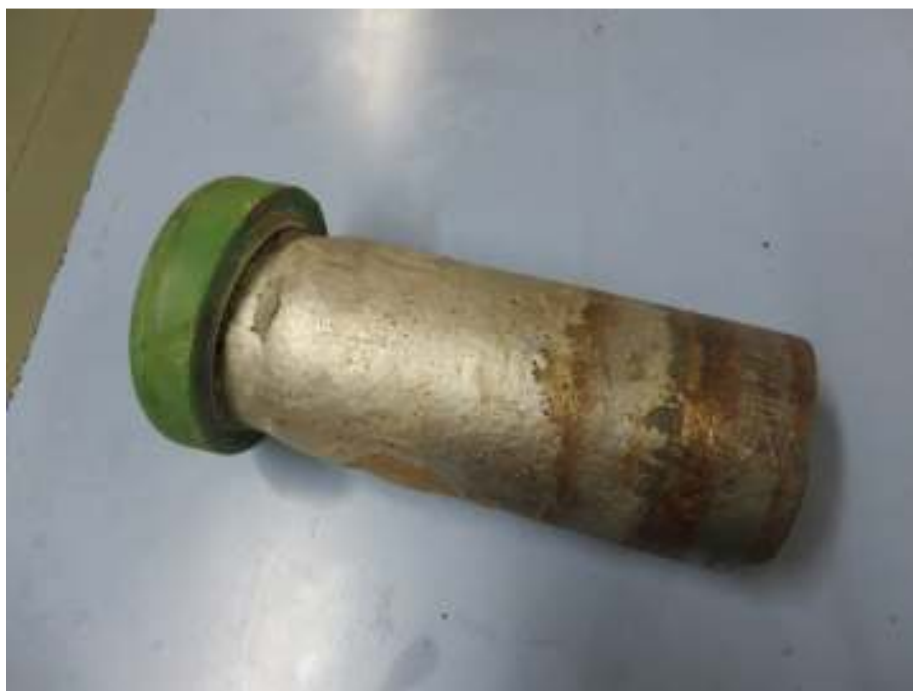
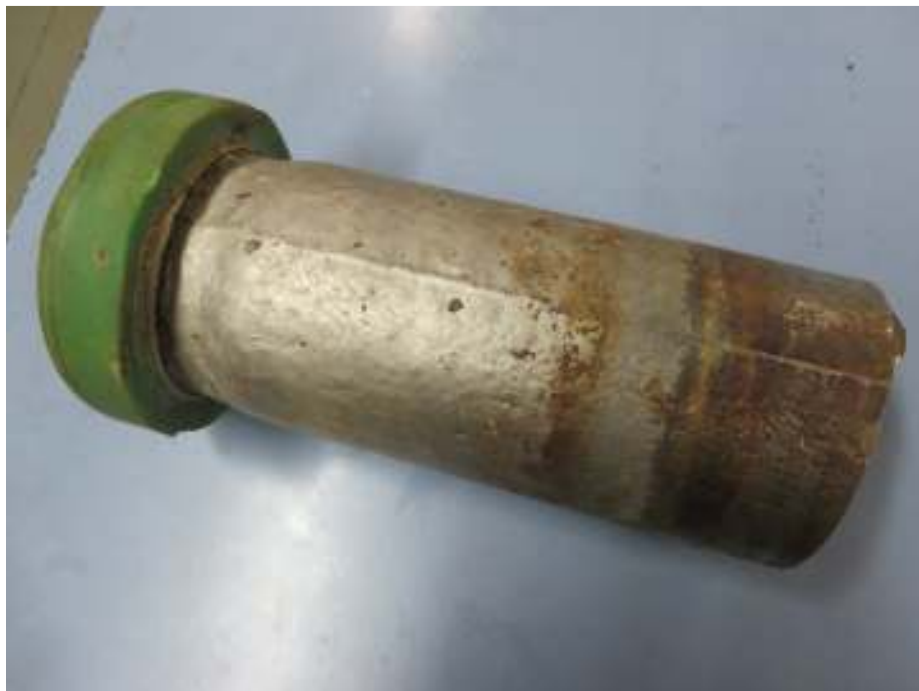
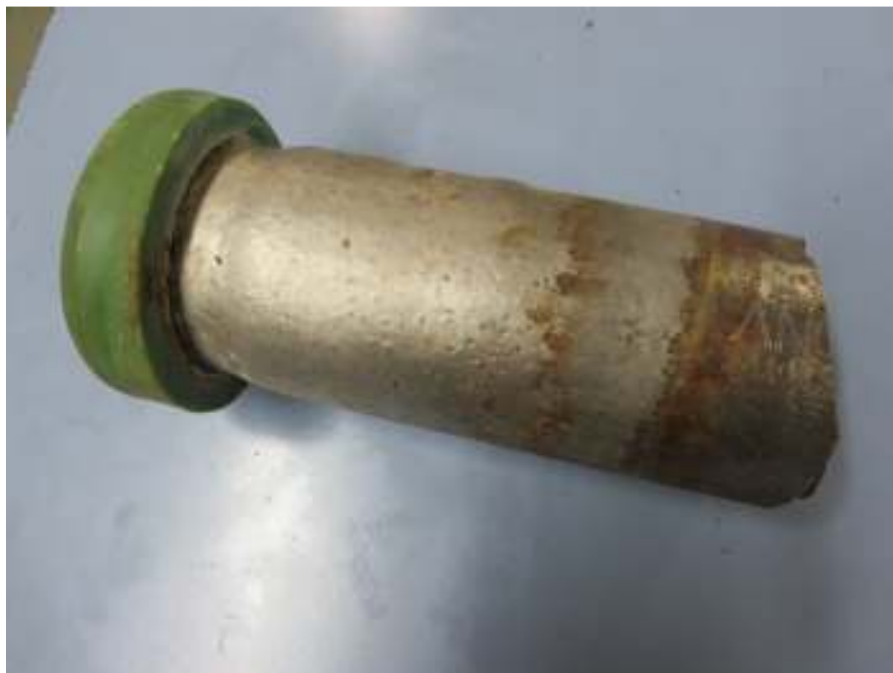
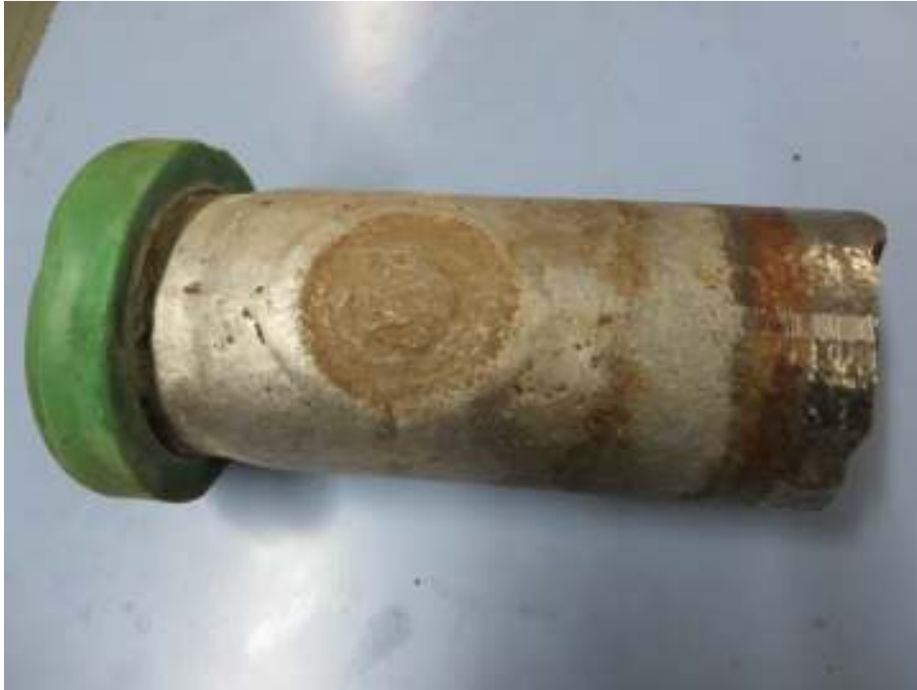
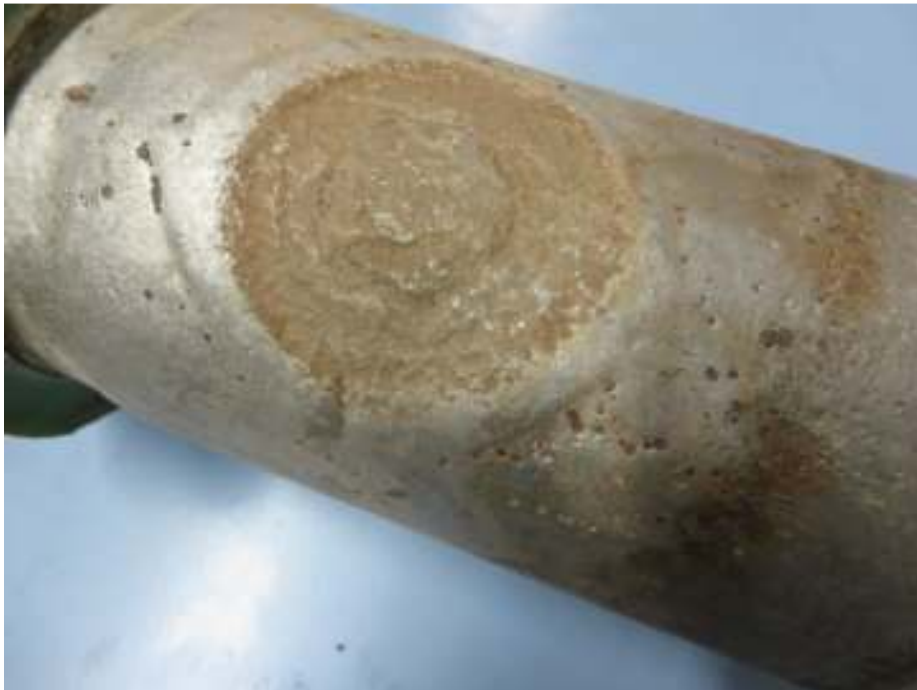
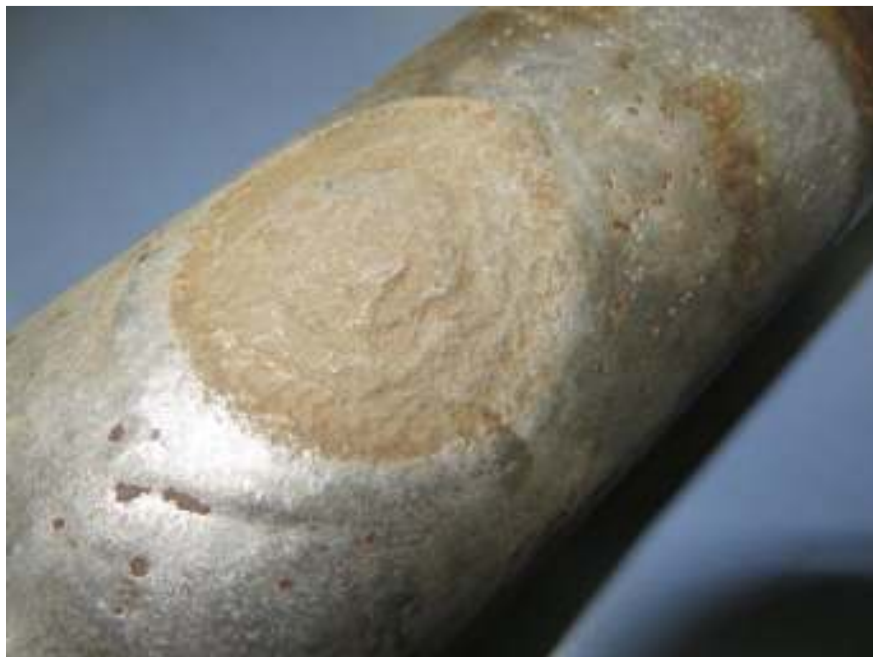
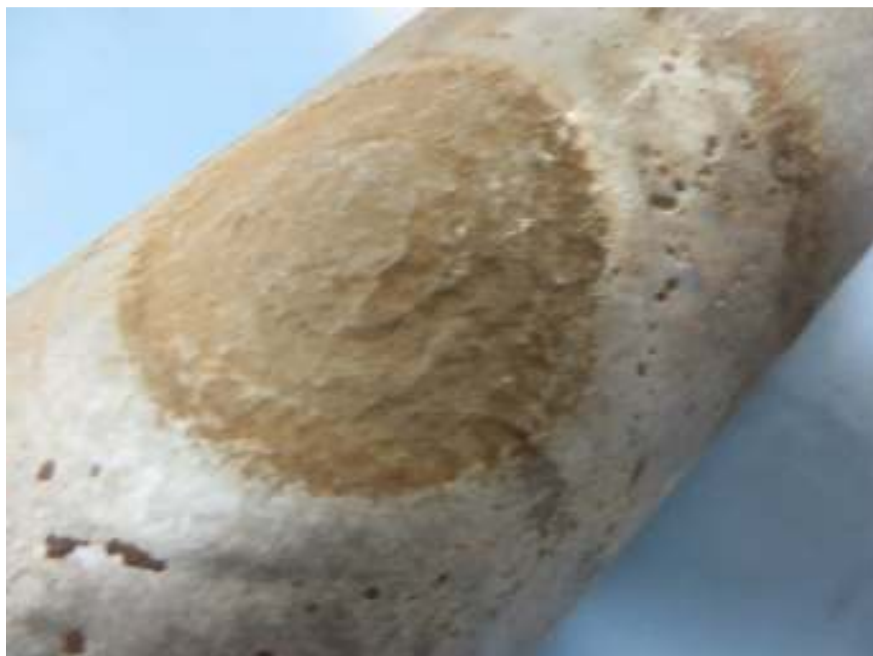
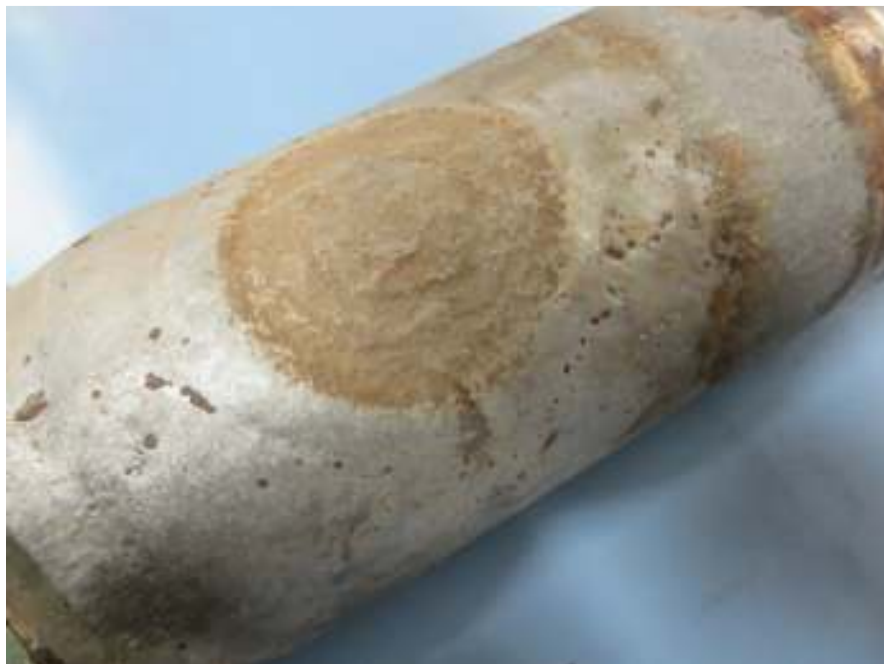
Photos 18 to 26 After cleaning
